As part of a large multi impounding reservoir spillways programme, Stonbury was contracted to complete works to a historic spillway and head wall as part of both safety and maintenance requirements.

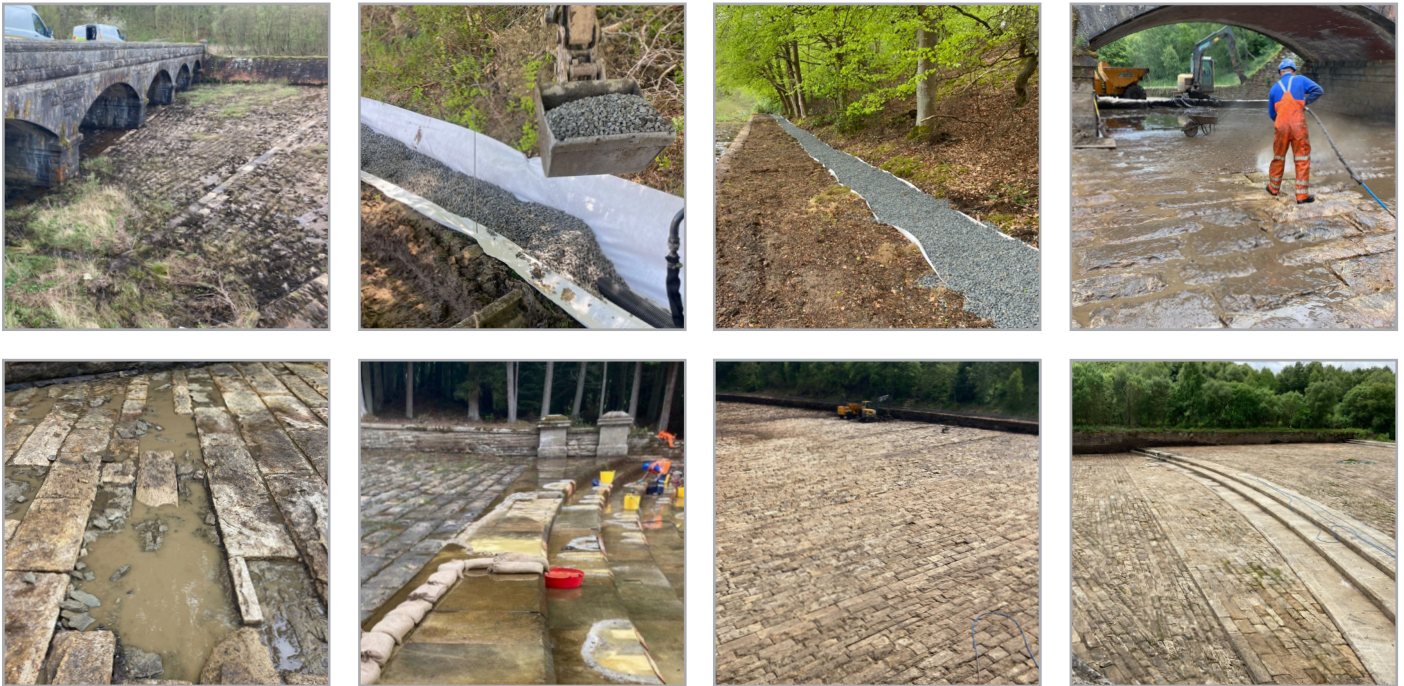
An impounding reservoir in the north of England required attention in several areas to enable inspection to take place and ensure it complies with the minimum standards set by the S10 inspection. Works included clearance of vegetation within the spillway, repairs to stonework, surface water drainage installation and removal of overburden and uprisings from the upstream stone face of the reservoir and wave wall structure.

To protect the watercourse downstream of the spillway, straw bales and silt curtains were installed at the bottom end of the spillway to catch debris and filter water to prevent contamination. Once the spillway was cleaned, a full inspection with the client's reservoir engineer was carried out and the team completed extensive repairs to damaged stonework along the spillway channel and steps.

hydrostatic pressure on the spillway walls. Stonbury was tasked to address this as part of the programme. Once the team had agreed a design with the client engineer, a trench was excavated along the entire southwest length of the spillway and a french drain was installed. The trench was then filled with stone until flush with the surrounding area. The drainage works showed immediate improvements to the ground conditions and this was evident within the flows of water from the outlet culvert.

To address sedimentation and overburden on the upstream face of the dam, temporary bog mats were installed to initiate safe access along the dam crest and machinery was used to remove most of the overburden. Potential damage to the stonework was minimised by installing a rubber tip to the excavator bucket and the last 50-100mm was removed manually. Once this was completed, repairs were made to underlying blocks that were damaged using an environmentally friendly, fast setting mortar.
