PROJECT NEWS

PROJECT IMPOUNDING RESERVOIR

PROCESSES SPILLWAY IMPROVEMENTS

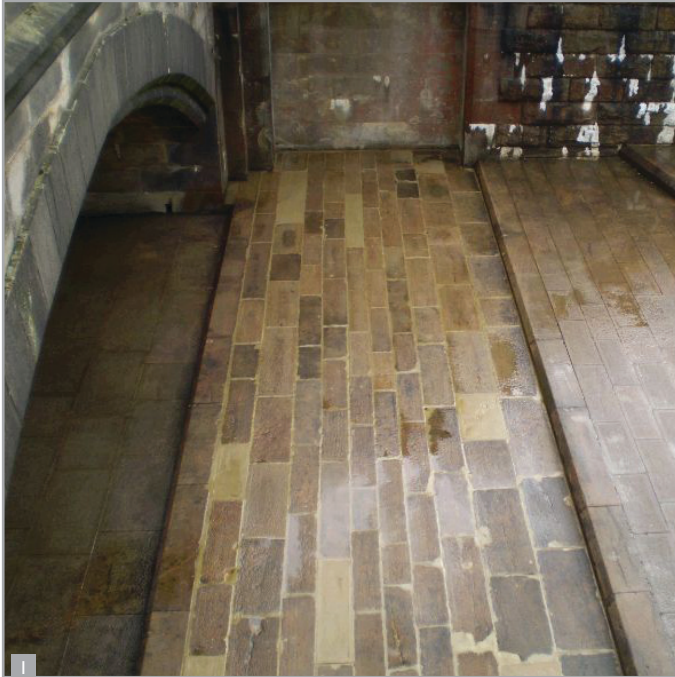
1. Sandstone sets replaced and repointed, job complete
2. Pre-Start Photo showing evidence of water washing under stone sets
3. Removal of sandstone sets
4. Excavation complete with steel reinforcement going in
5. New reinforced concrete slab in place

After completion of this work, the sandstone blocks were bedded back in their original positions, to include some new replacements, and re-pointed.

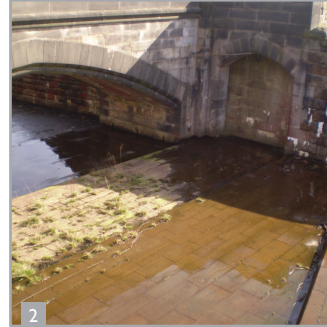
This section of sandstone masonry was reported to have 'significant' leaks with water passing down and under the sandstone masonry and exiting down stream at the next section.

Drawings and investigations determined that the sandstone blocks upstream and downstream of this section, were bedded in most locations on a 300mm thick concrete slab, whilst this section had been bedded directly on to the puddle clay core.
