PROJECT FLOOD MITIGATION

Stonbury was contracted by the Environment Agency to complete an initial vegetation cut, followed by other flood mitigation measures on an 800-metre stretch alongside the River Isbourne through Sedgeberrow.

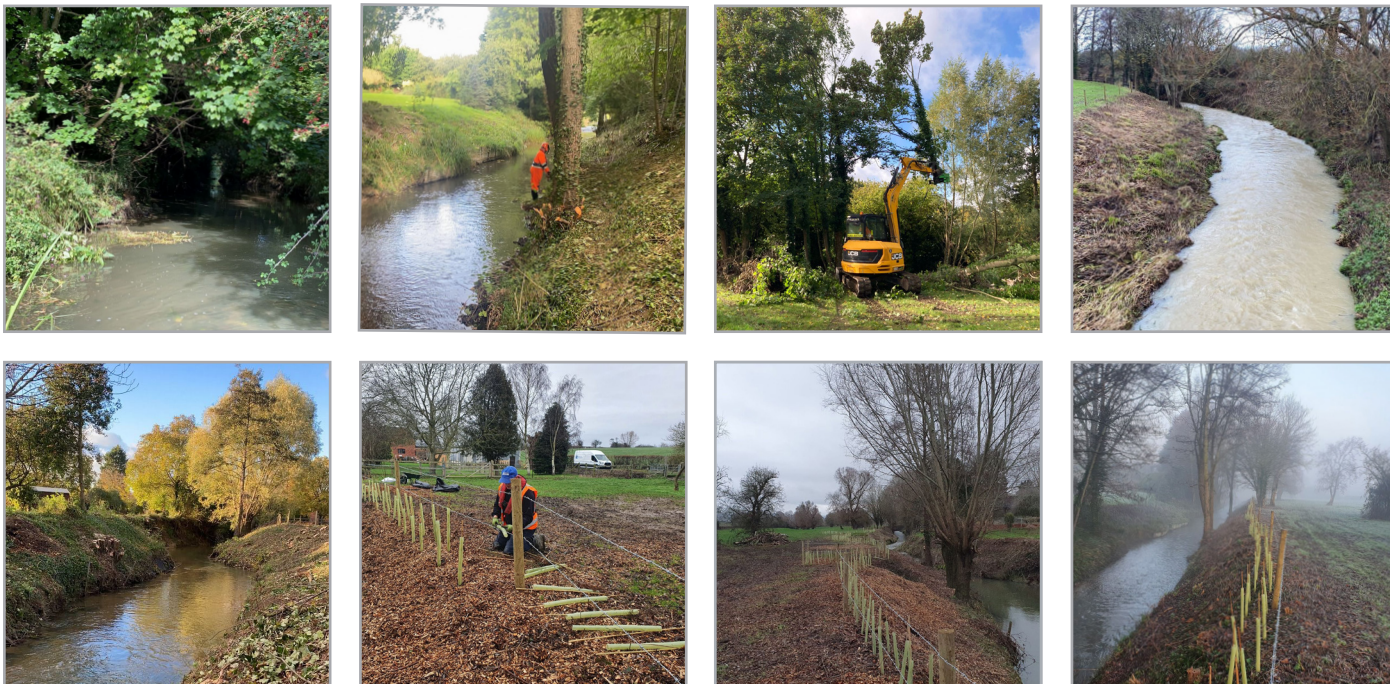
The initial vegetation cut was made from the shallow water course so we could avoid working from within the channel once we moved into the salmonid spawning season. We removed vegetation from the channel bed up to the top of the banks and from around in-channel structures such as outfall headwalls, bridges, and flood walls. Trees under 200mm in diameter were also removed.
