As part of a significant multi-site wastewater treatment works framework, Stonbury was pleased to deliver the refurbishment of a brick sludge tank, returning the vital asset back to service.

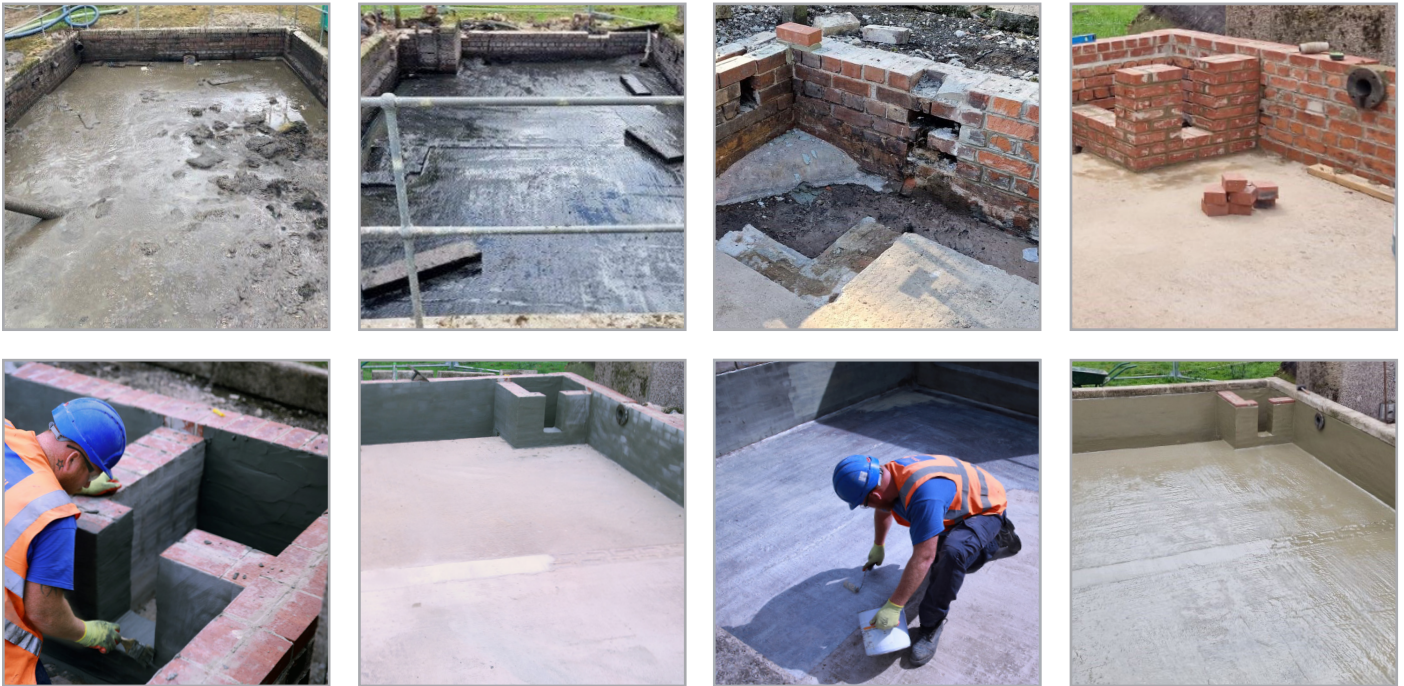
The sludge tank is part of a small rural operational wastewater treatment works and had been leaking for some time, causing saturated ground and run-off onto adjacent land. Site investigations revealed extensive damage to the brick wall, extensive leaks, settlement and some previous repair attempts.

The sludge tank was isolated, drained and cleaned using a high-pressure water jet to remove loose material and prepare the substrate. To maintain the operational functionality of the works, a tanker was also used every week to de-sludge the primary tanks.

The team replaced all damaged brickwork and substantially rebuilt the walls on the south and west side of the tank. In addition, at the request of the client's operations team, the old decanting chamber in the southeast corner of the tank was removed and rebuilt in the opposite corner.

All previous brickwork joints were then ground out and repointed. A waterproof render was applied to create an internal seal, followed by the application of a flexible membrane resistant to sulphuric acid chemical attack.

Finally, the team replaced a dilapidated timber post and rail edge protection at the south end of the sludge tank. After curing, the tank was inspected and returned to service immediately. The project received exceptional feedback from the client's operations team.
