Stonbury was pleased to deliver replacements to several gate valves within a water tower during a four-week programme.

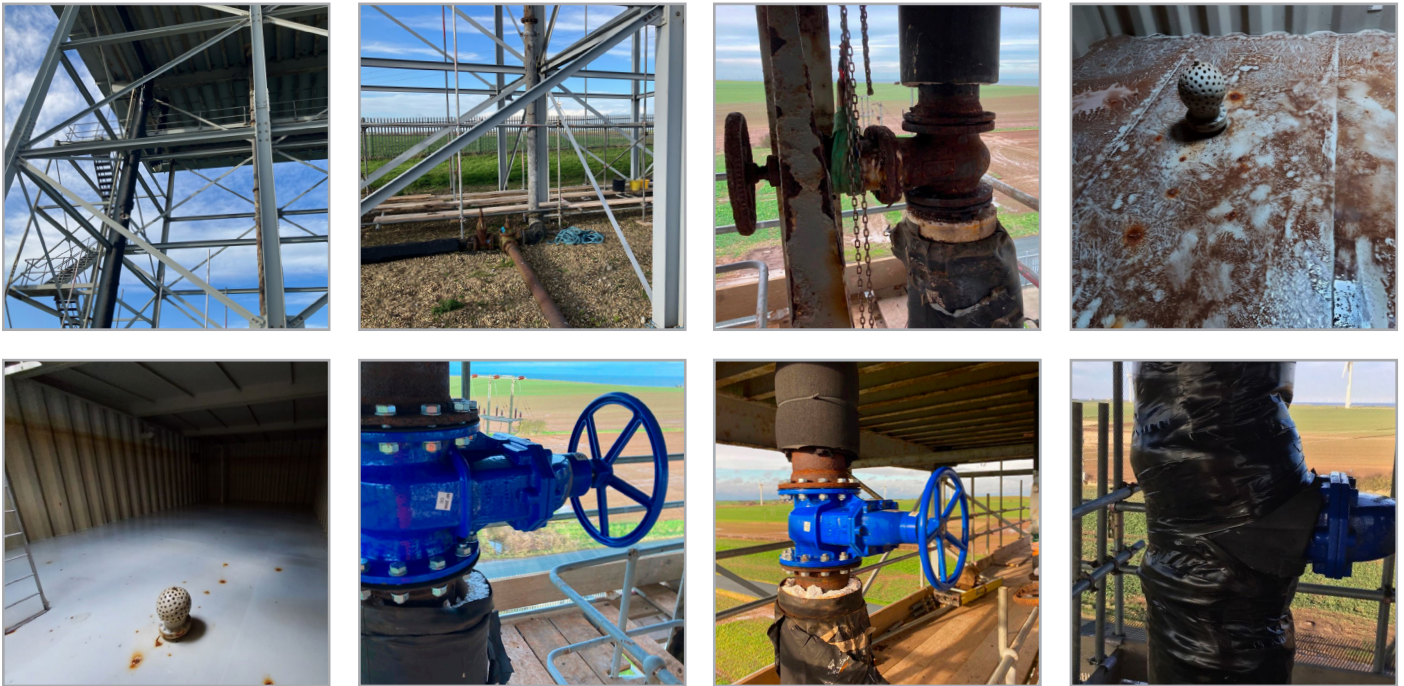
Stonbury was contracted to replace six valves on the external mains on the underside of a water tower as they had decayed over the years due to inclement weather from the North Sea and were no longer fully operational. Stonbury was chosen to deliver this time-critical project after it was decided that employing its particular skillset would keep the timescale and cost to a minimum.

Once safe access was established, the team removed and replaced four large, defected valves on the inlet and outlet pipes followed by two remaining WO valves, which assist in emptying the tanks. Lagging was installed on all the valves to protect them from freezing temperatures.

In addition to the valve replacements, the team completed some minor repair works to the tank itself. Metal plates were installed to two areas on the underside of the tank floor where leakage had been identified resulting in corroding of the steel floor. Finally, the tank was washed down before the scaffolding was dismantled and the asset was returned to the client.
