PROJECT DIGESTER REFURBISHMENT

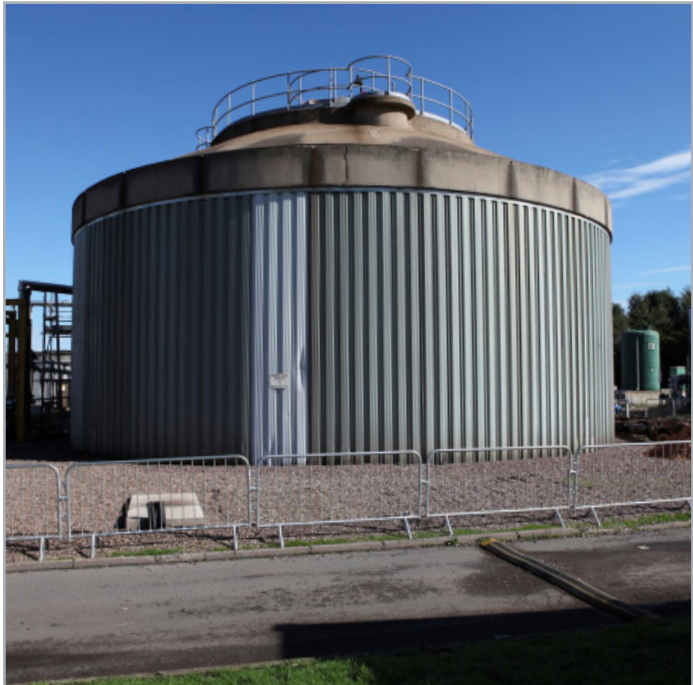
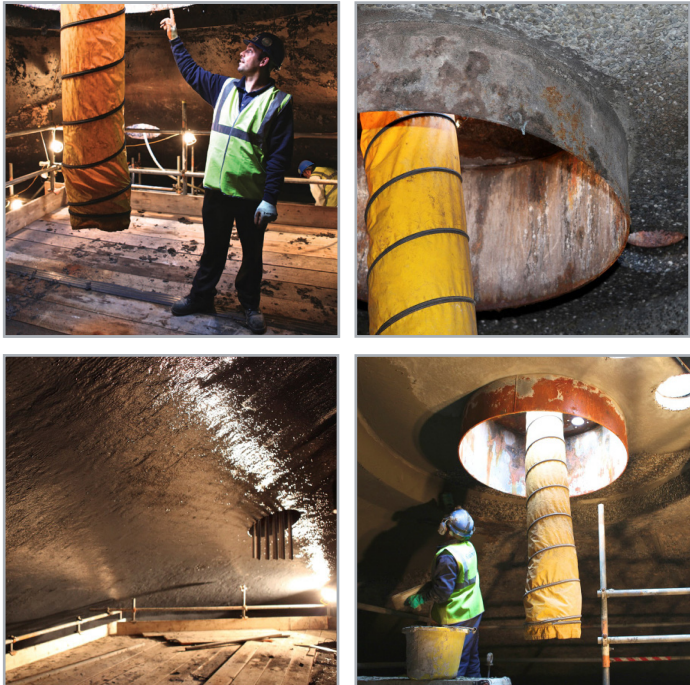
Stonbury were recently commissioned to carry out refurbishment works to the gas zone of a Digester. The inspection to the soffit, revealed that the existing coating had failed and that the exposed concrete had suffered from attack by the Hydrogen Sulphide gases.

It was decided that the existing failed coating system should be removed from the soffit, extending 1m down the walls. Ultra high water jetting was the preferred preparation method, however after an initial attempt that left traces of well adhered coatings, reparation was completed by open grit blasting.

This method also left a key to the substrate, ideal for the application of a new protective coating system. Following grit blasting a termination chase was formed 1m down the wall, ready for the new system to be addressed into.

After removal of spent grit, the digester was jet washed clean. Any repairs identified to the soffit, deeper than 5mm were repaired with rapid set high density repair mortars. This was followed by the application of a cementitious levelling compound to all prepared areas, to provide a suitable surface for the subsequent coatings.

After 5 days cure on the levelling compound, a primer and 2 full coats of a chemically resistant, elastomeric, polyurethane coating was applied by brush and roller, terminated into the previously formed chase, and sealed using a single pack polyurethane joint sealant. Materials were then left to cure and the digester was handed back.
