PROJECT NEWS

PROJECT WATER TREATMENT WORKS - RAPID GRAVITY FILTER TANKS
 PROCESSES HIGH PRESSURE WATER JETTING, CONCRETE REPAIR, SPECIALIST WATERPROOF COATINGS

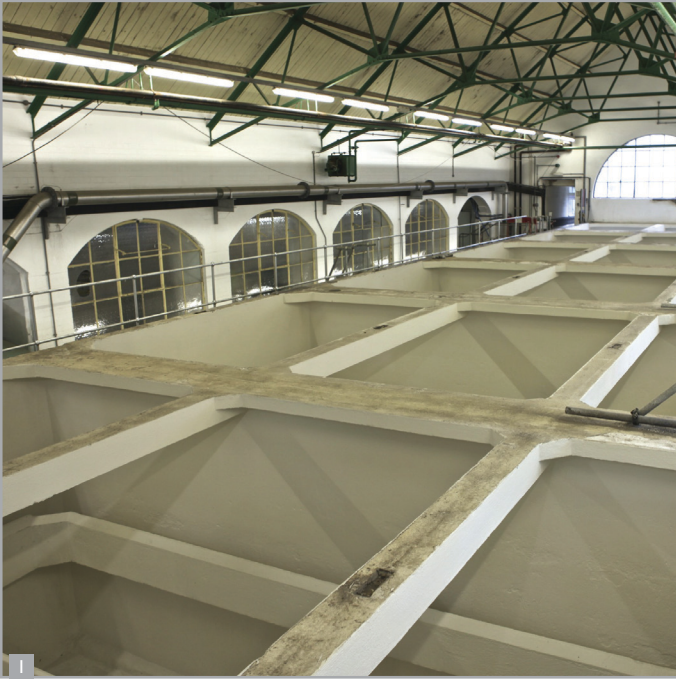
1. Overhead section of completed tanks
2. Application of elastomeric waterproof coating
3. Tank floor with pipes before works
4. Tank floor with concrete repairs
5. Completed tank

Stonbury were recently contracted to carry out refurbishment works to 22 Rapid Gravity Filter tanks and outfall channels.
