As part of a Wastewater Framework, Stonbury was enlisted to complete refurbishment works to a filter tank in the north of England.

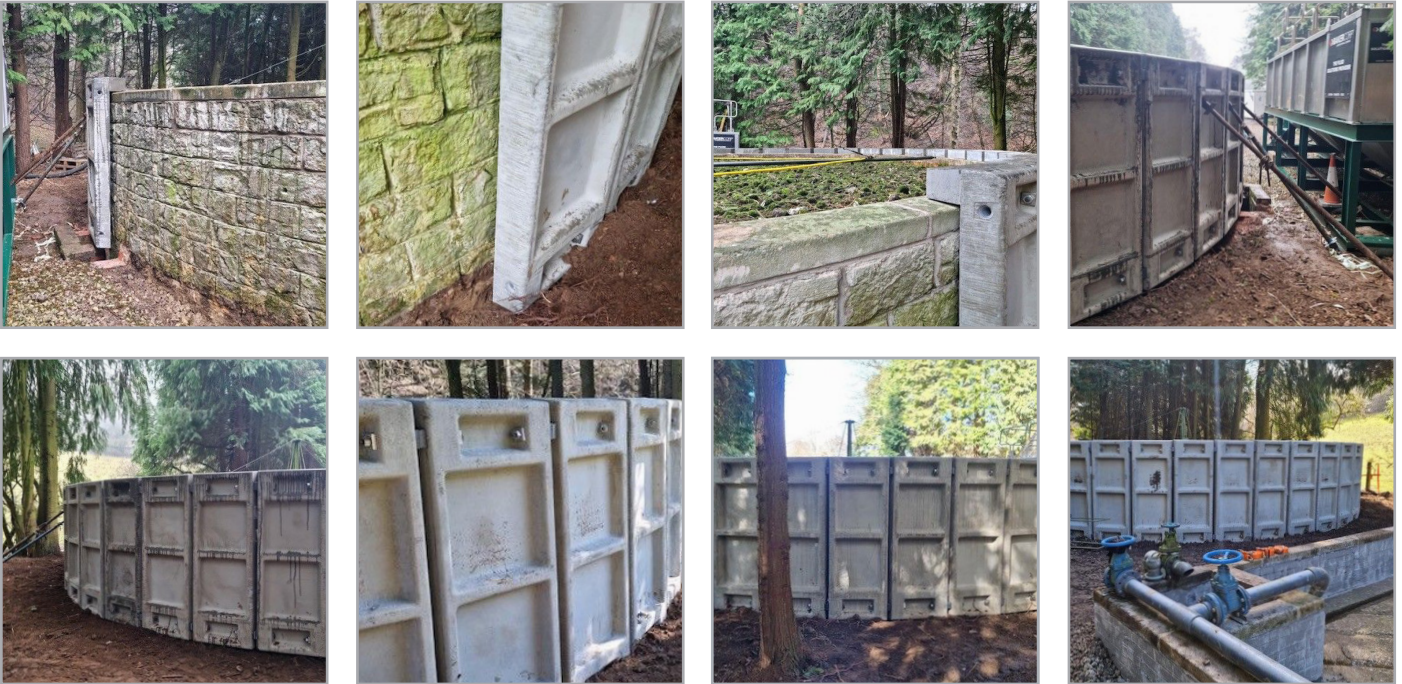
Stonbury was contracted to refurbish and modify a circular stone-walled filter tank after some sections of the tank wall had begun to lean outwards. In addition, several stone blocks had become dislodged and fallen out, leading to the asset being deemed unsafe to access. This meant that the rotating filter arms could not be accessed for maintenance and repair.

To begin, the team put restraining ratchet straps around the tank to avoid further movement occurring. This allowed them to dismantle and rebuild the leaning parts of the wall,

replace the dislodged blocks, and repoint blockwork where joint mortar was missing.

The tank was then encased by interconnecting pre-cast concrete panels to form a circular band around the tank to prevent any further outward movement of the wall. The panels were lifted into place using a tracked digger and temporarily stabilised with Acrow props until the full circle was connected.
