PROJECT RAILWAY CULVERT REPAIRS

Stonbury was awarded a scheme to carry out brickwork repairs to a 50-metre-long Victorian-built flood alleviation culvert after the railway company completed a structural report and found issues with the brickwork.

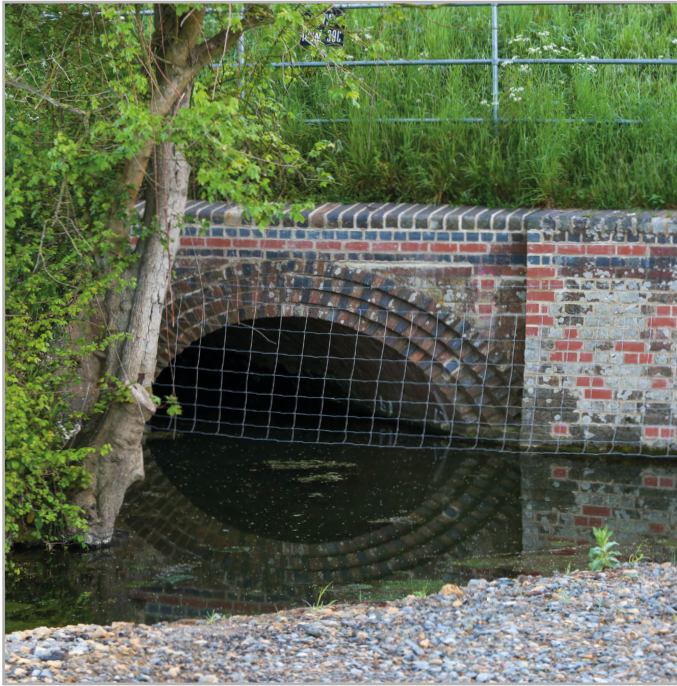
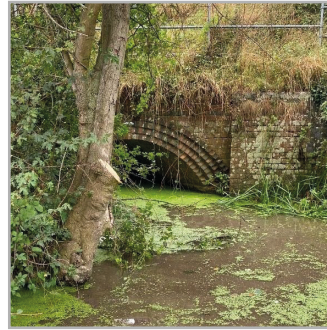
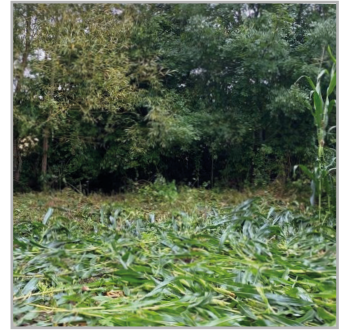
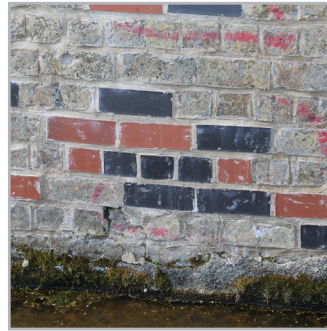
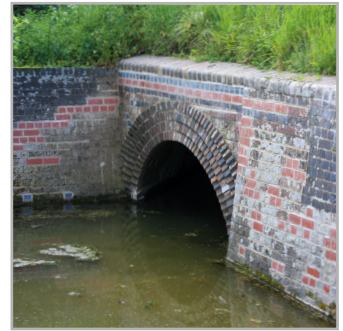
Once the structure was accessible, the team jet-washed the brickwork clean so that a thorough inspection could take place. During this inspection they identified several hollow bricks and crack lines not previously recorded on the initial survey.

All hollow bricks were removed and replaced, and crack lines were grinded and repaired with crack stitching. About a 20 metres squared area of crack stitching was completed and around 500 bricks were replaced.
