MAINTENANCE REFURBISHMENT NEW BUILD

PROJECT STORM LAKE REFURBISHMENT

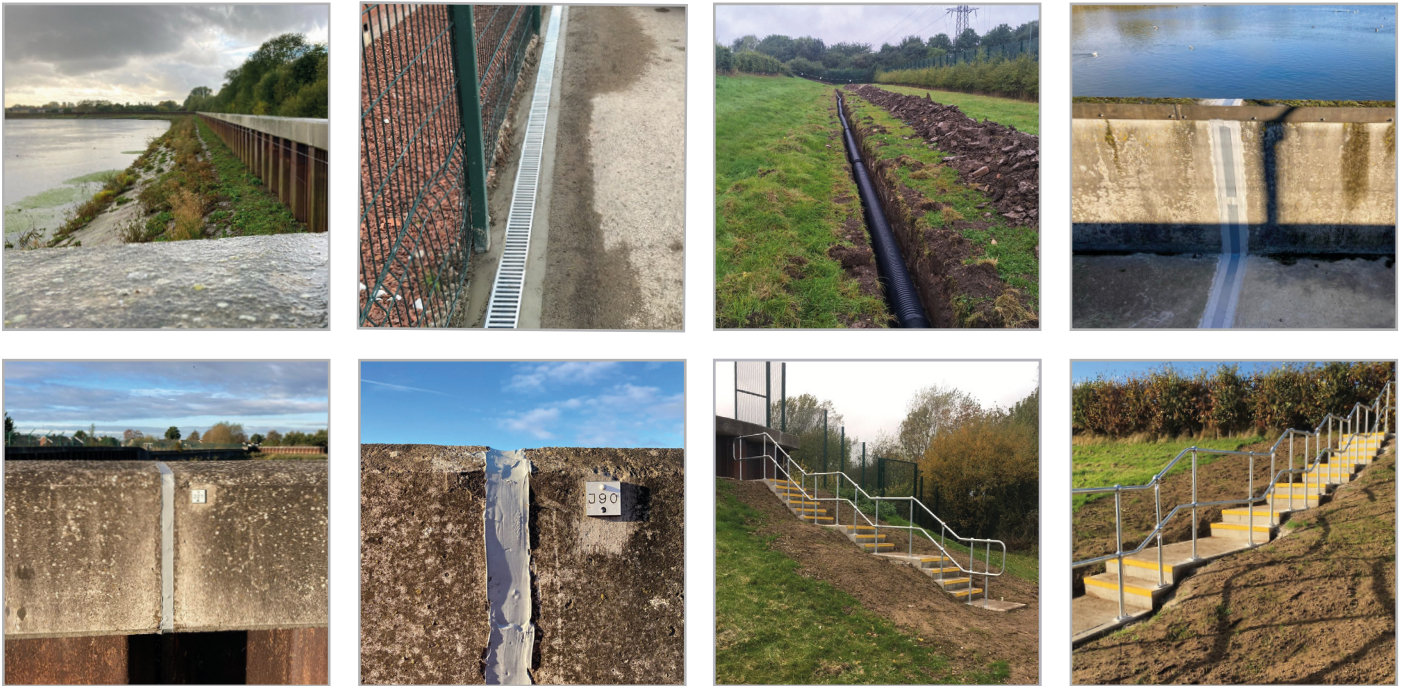
Stonbury was recently contracted to undertake various works to refurbish a storm lake. The main purpose of the programme was to alleviate flooding around the site, to improve access, and complete concrete repairs to the inside of the lake wall.

A housing development was built adjacent to the storm lake which resulted in flooding along the access road, requiring prompt attention. To solve the issue, the team saw-cut a breakout channel of approximately 150 metres along the tarmac access road and installed a clerk drainage channel to take water away from the road into a soakaway chamber.

To address flooding on the front elevation of the storm lake, a channel was excavated and approximately 150 metres of 225mm perforated toe drain was installed to the front elevation of the storm lake and connected into the existing drainage chamber.

Once drainage works had been completed, work began on the internal remedials. All mastic mastic sealant from concrete capping within the storm lake and installed a total of 90 numbered plates next to each joint internally and externally so that the client could identify individual joints if future remedial works were required.

Finally, the site team replaced the existing overbanding on the inside of the overflow wall where two joints were leaking and installed new overbanding to all the full joints using Masterseal 933 epoxy adhesive. Minor concrete repairs were conducted where necessary using Natcem 35.

In addition to the drainage improvements and lake repairs, access provision was improved with the construction of two new concrete staircases, one to enable access up the front embankment, and one to enable access to the left side elevation. Handrailing was then installed by a client-approved metalwork installer who supplied the fabrication and fitting.
